## Jigsaw Puzzle Pelvis

By Steven T. Tanaka, DC

(From the September 2008 “G”Note)

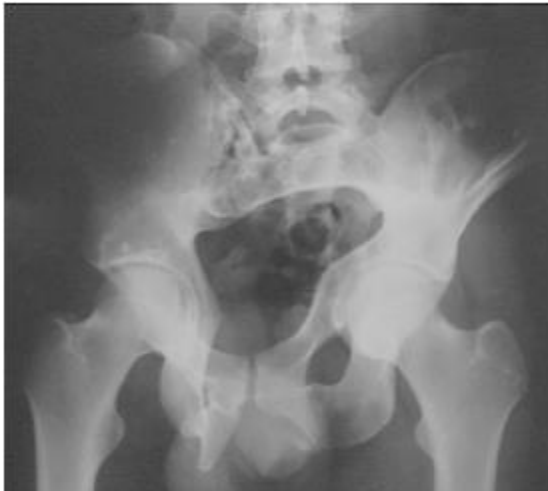
I didn't think to photograph the original post-accident films – they were scary to look at! As you might imagine after looking at the above film, the ilia and sacrum were in pieces in the first films. This post film was taken in 2004, 10 years post-accident. Note the bar of bone across the upper aspect of his sacrum that joins the ilia. It palpates like it looks.

The x-ray was photographed in front of a window that was covered with black plastic. Not quite viewbox quality. The lateral copy that I made, which was the lateral full spine film, was too dark. L4 and L5 appeared posterior with lumbar hypolordosis. ✱
